**Flood Control Project Maintenance
Levee Inspections**

Fall 2012 Levee Maintenance Deficiency Summary Report

Sutter Maintenance Yard Maintenance Area 0017

Waterway			Bank	Unit Miles
Unit No. 01 Lake County Sutter Maintenance Yard - Middle Creek			Left	3.90
	Spring (March - May)	Summer (June - August)	(September - November) Fall	Winter (December - February)
Unit Maintenance Rating (Fall Only)			U	
Date of Inspection	03/14/2012 - 03/14/2012		11/13/2012 - 11/13/2012	
DWR Inspector	Bob Duffey		Bob Duffey	
Accompanied By	Bryan Reniff Sutter Yard		Bryan Reniff Sutter Yard

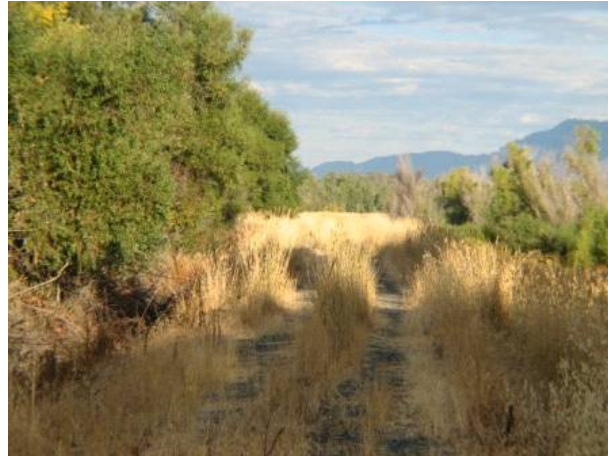
Levee Mile Report Line	4
Start Levee Mile	4.18
End Levee Mile	7.30
Location	Water Side
Category	Earthen Levee
Item	Trim / Thin Trees

View of the trees on the waterside slope of the Levee.

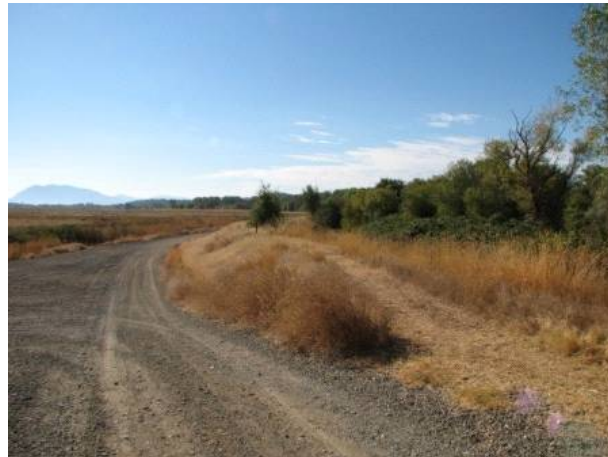
Levee Mile Report Line	5
Start Levee Mile	4.18
End Levee Mile	7.31
Location	Water Side
Category	Earthen Levee
Item	Vegetation

View of the six-foot crown levee & heavy vegetation on waterside slope.

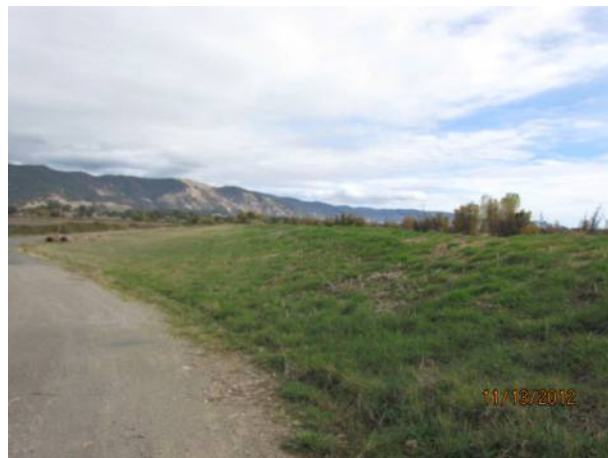
Levee Mile Report Line	6
Start Levee Mile	4.18
End Levee Mile	7.30
Location	Land Side
Category	Earthen Levee
Item	Vegetation

View of levee that has been mowed and clear of all vegetation.

DWR ID: DWR_MA0017_01_s_2012_1										
6	4.18	7.30	Earthen Levee	Vegetation	LS A Ob	V1 : Control annual grass and weeds on the levee slopes and easements.	39.142155 ° -122.902343 °	39.142155 ° -122.902343 °	4 Y	
DWR ID: DWR_MA0017_01_s_2012_4
